TRASH AND DEBRIS IN THE WEST RIVER

NRCA Student: Jahlyn Lowndes¹; Community Partner: Kendall Barbery²

¹Sound School; ²Save the Sound

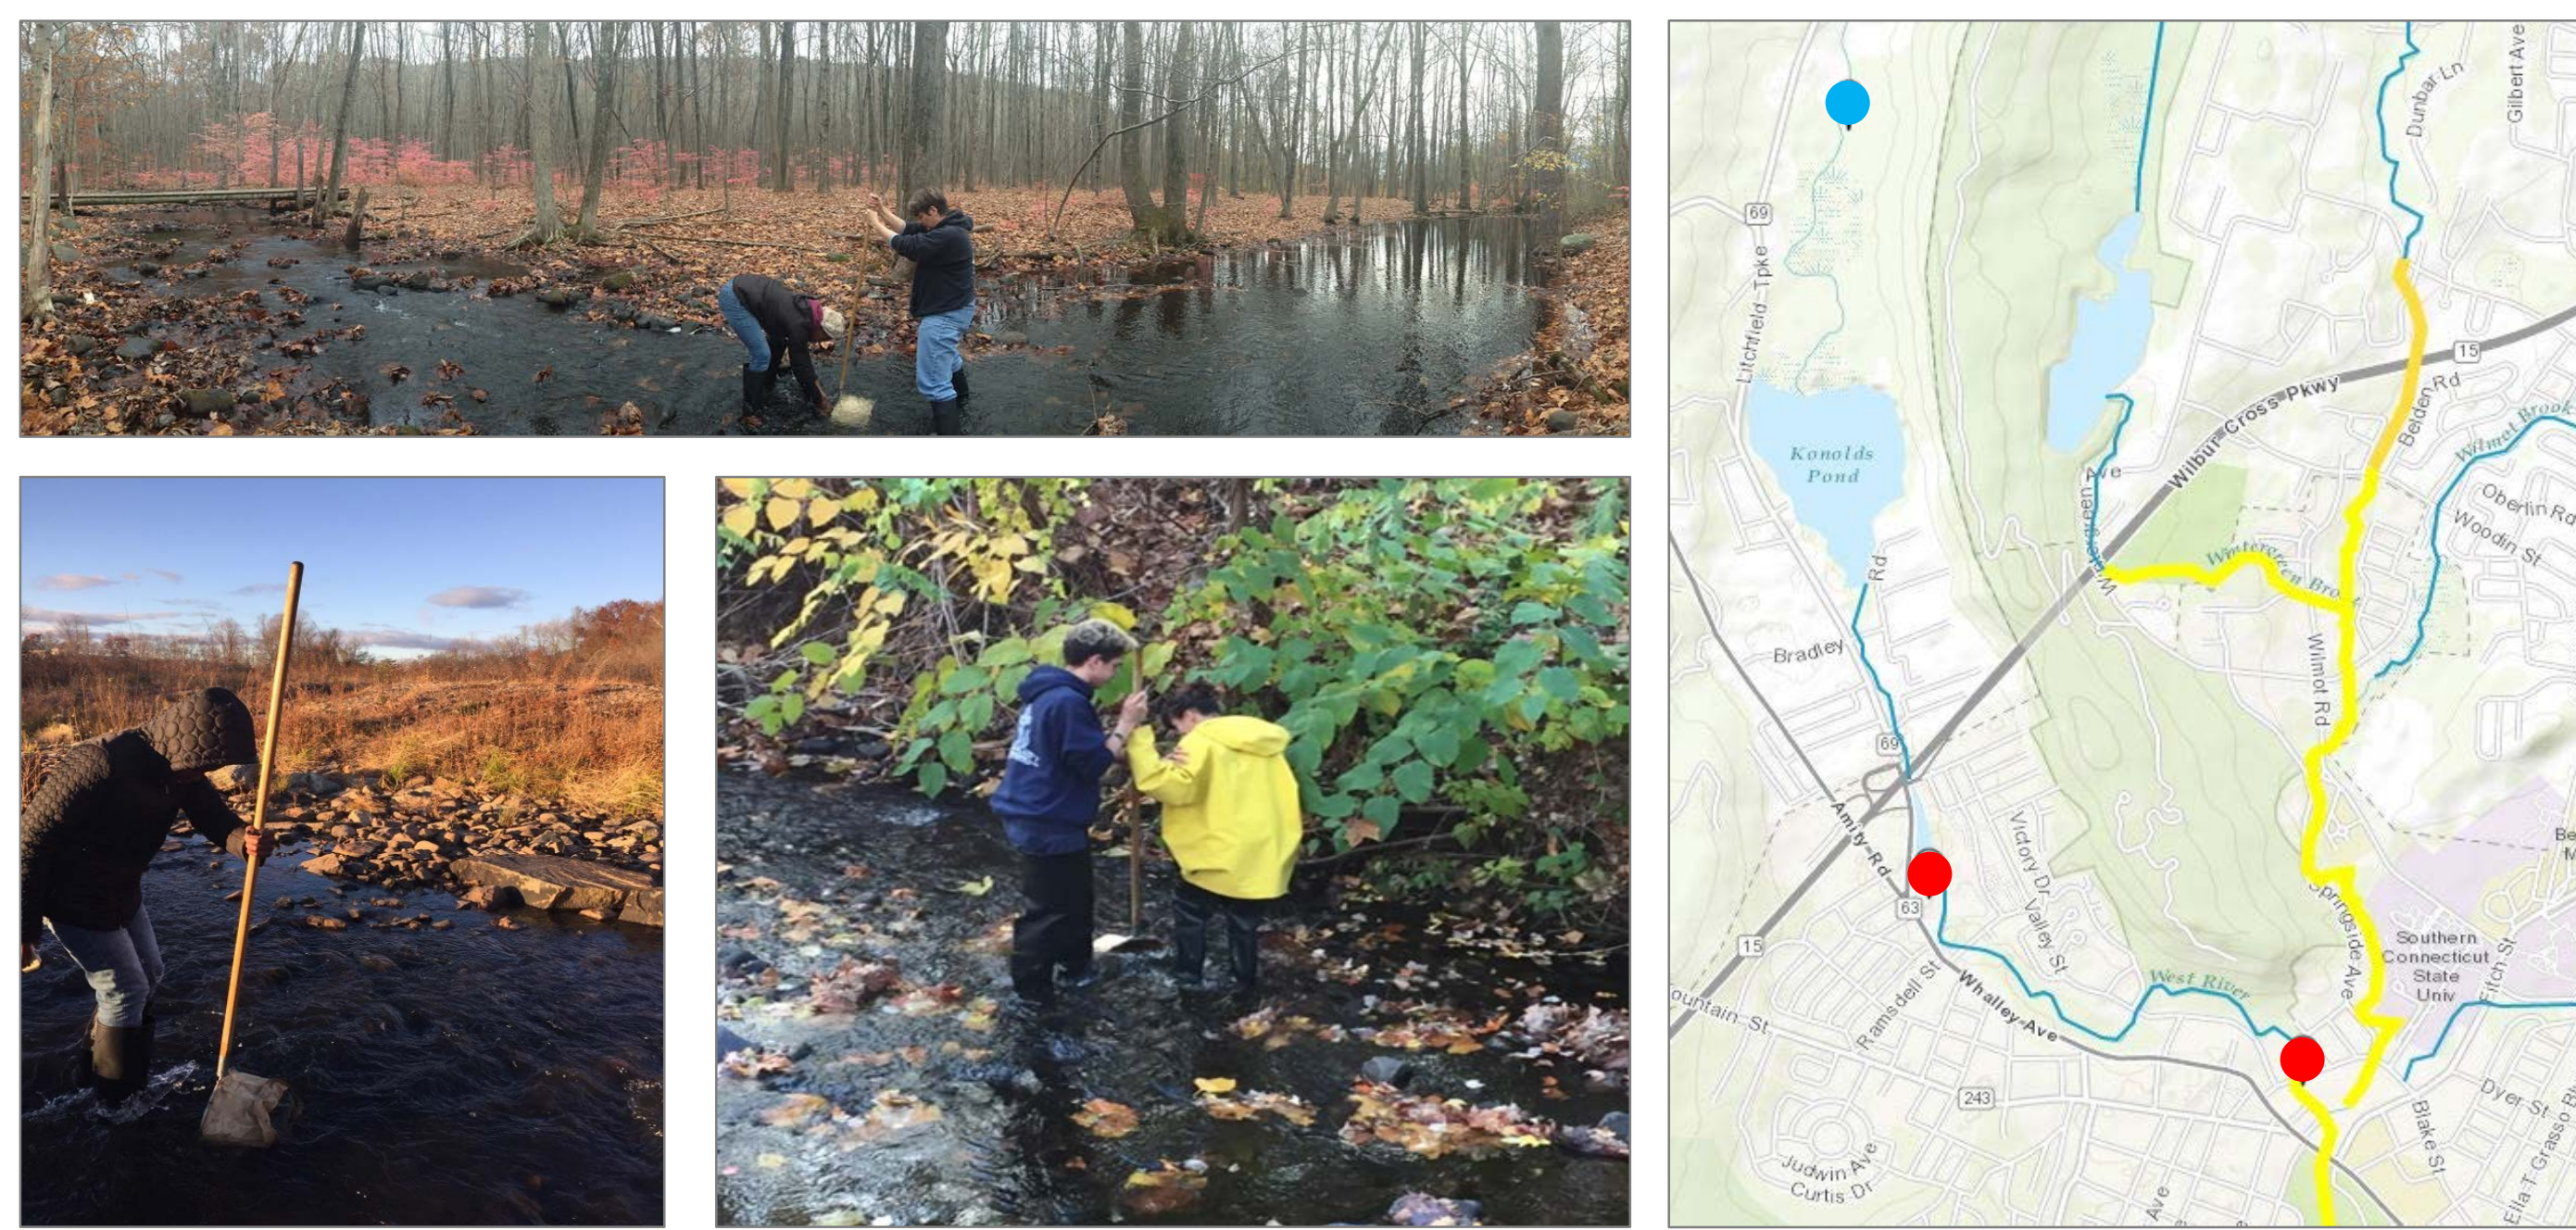
Fig 3. Macroinvertebrate survey areas are indicated by the dots in the map below. Results indicate:

- (Blue dot) The reach just below Lake Dawson had excellent water quality.
 - There was an abundance of macroinvertebrates and a lot with low tolerance.
- (Middle red dot) This reach LW5 had fair water quality.
 - In these results, the number of different types of organisms was low; there was not much community balance or presence of low-tolerance organisms.
- (Lower red dot) This last reach LW6 had very poor water quality.
 - As we went through the results we were baffled to see 788 Hydropsychidae and only 6 other different type of organisms! We figured the abundance of Hydropsychidae was because they are collector filterers with high tolerance, which means when the dam was removed releasing all the old leaf material it was the perfect environment for them to flourish.

- Three stream reaches surveyed include: Upstream LW5, Upstream LW6 (Fig. 3; red dots), and the reach that was used as a reference just below Lake Dawson in Wilnot Brook (Fig. 3; blue dot).
 - Upstream LW5 had trash and debris.
 - Upstream LW6 was not fully surveyed by volunteers, due to a recent dam removal project—but there was evidence of trash and debris problems.
 - A reach just below Lake Dawson is a reservoir that feeds the West River.

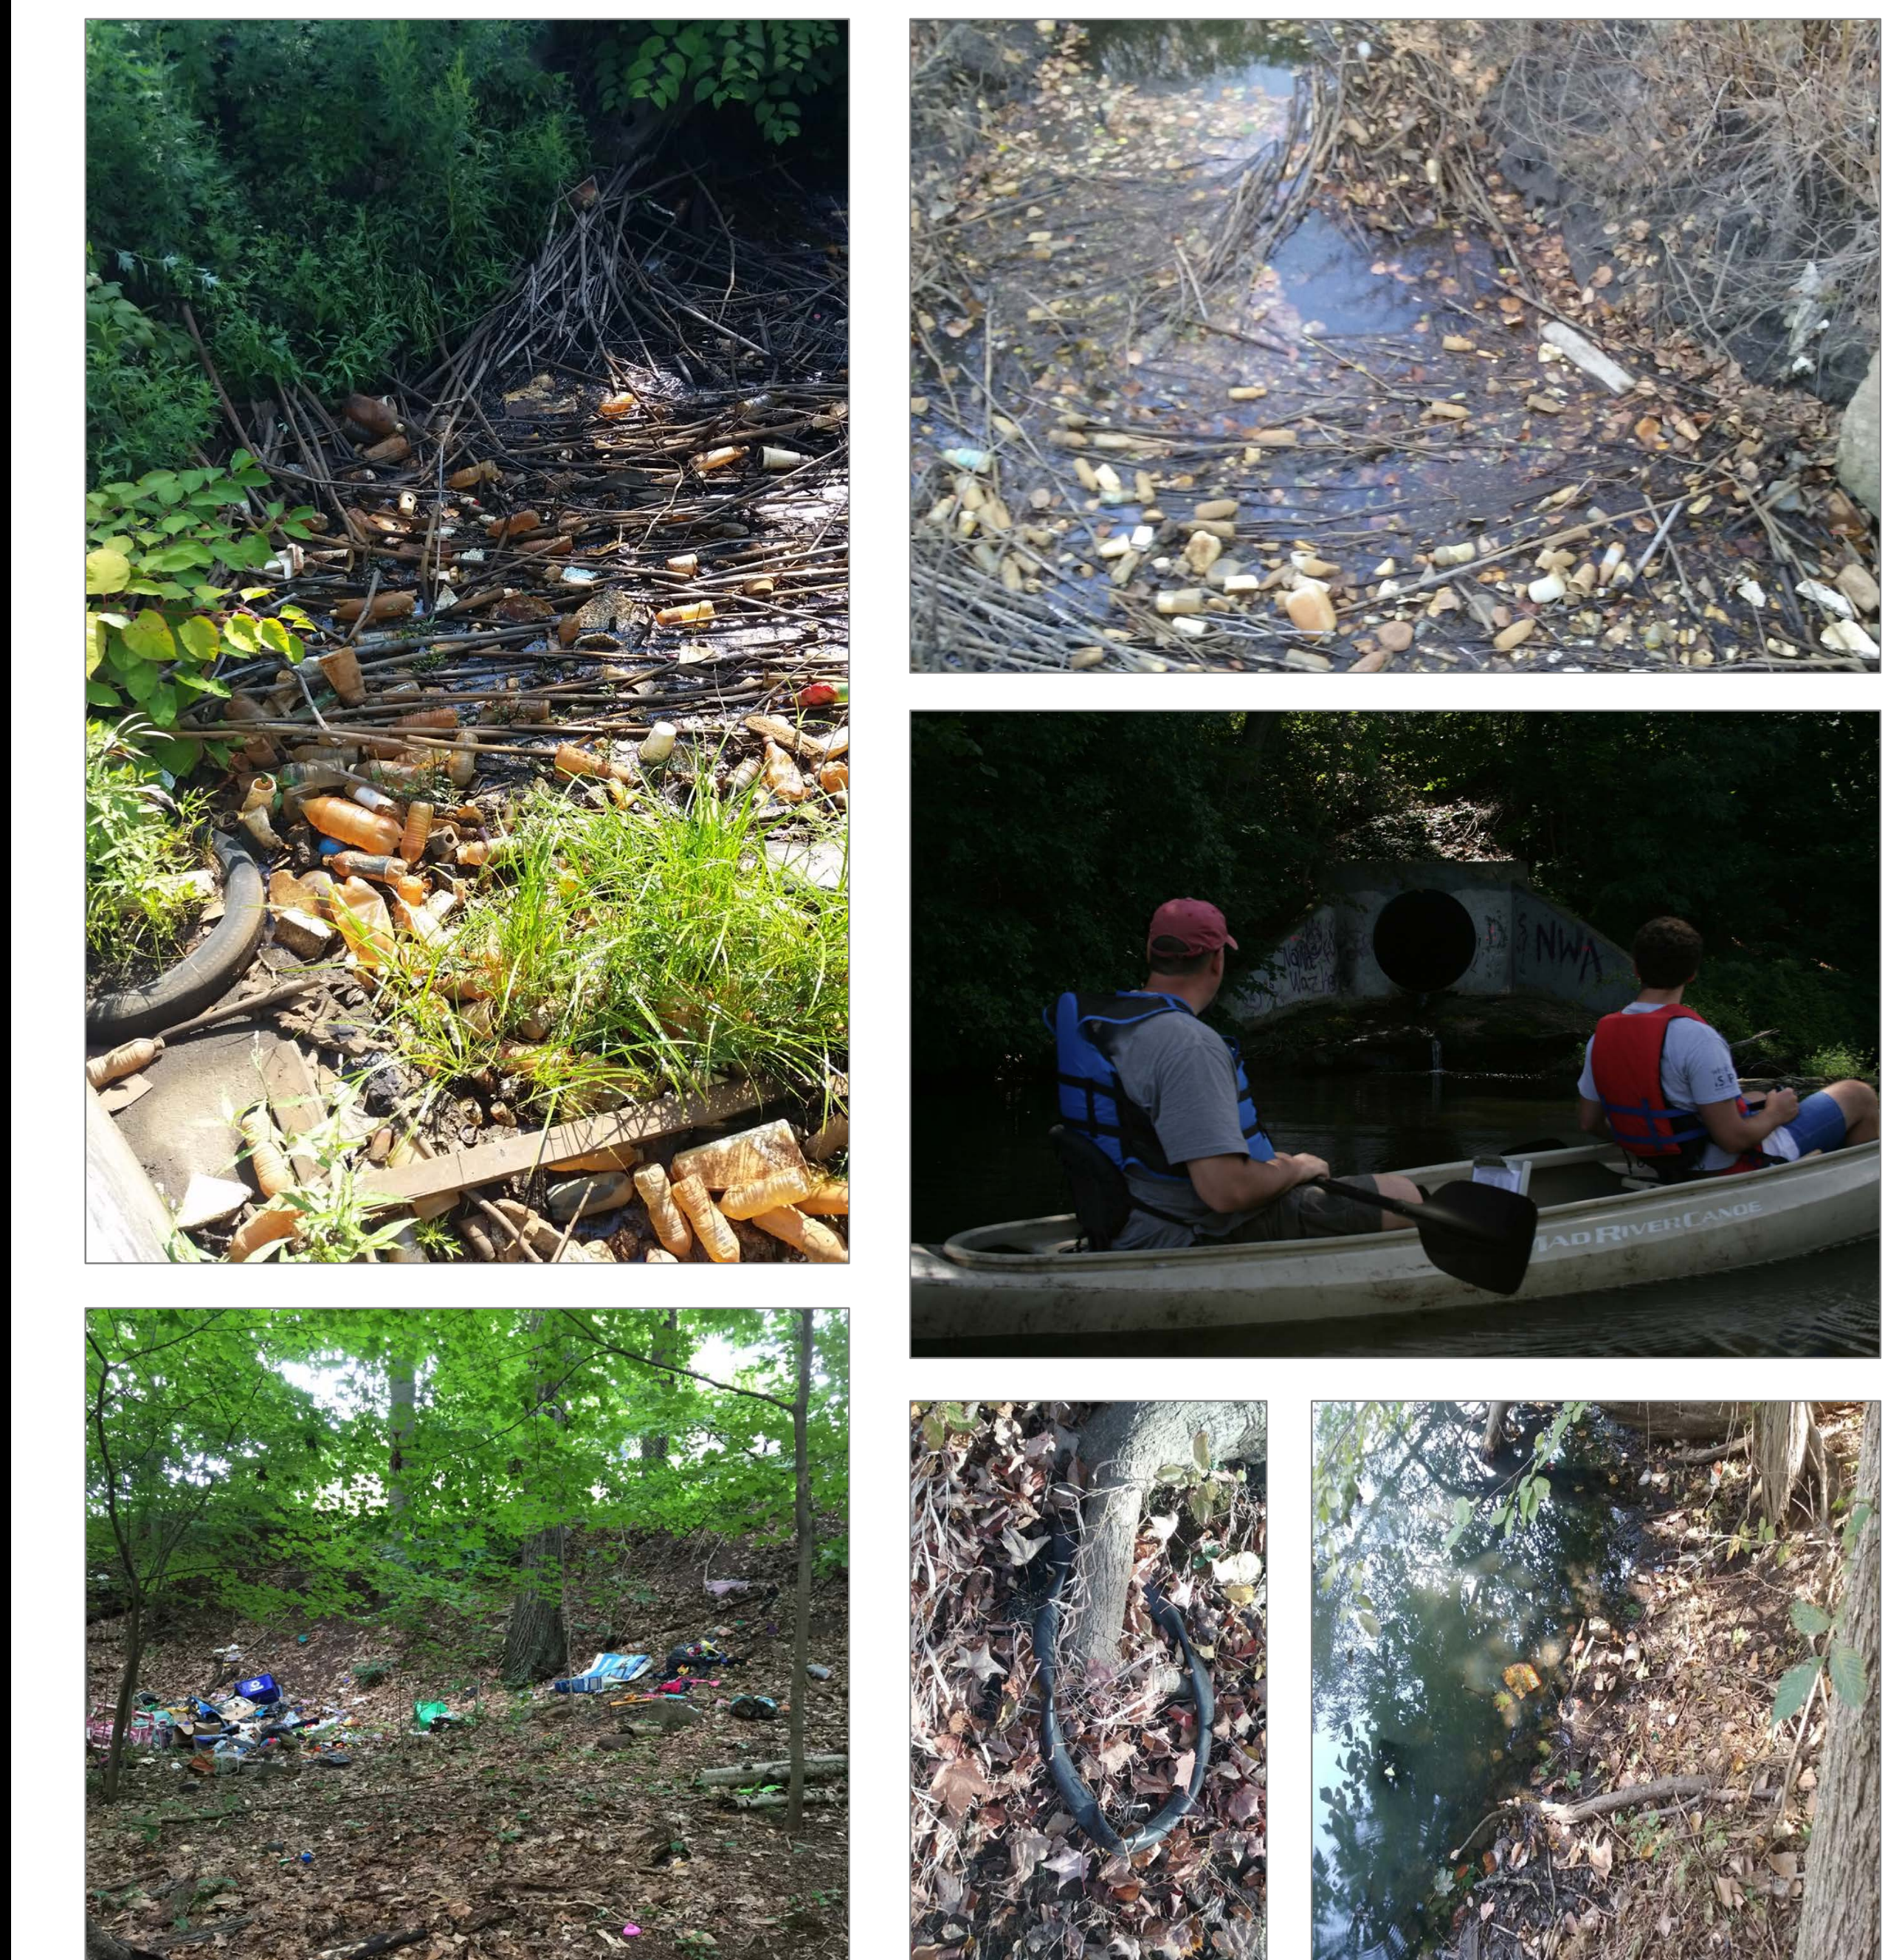
Fig 1. The above photos were taken during the watershed surveys conducted by volunteers of the West River Watershed Coalition. (Upper left & right) Example of trash debris documented at the same section of a stream reach (ALW2) on 7/28/15 (left) and 10/28/16 (right). (Middle right) A stormwater outfall on the West Haven side of the lower West River (LW4). (Lower left) A photo of residential garbage in the riparian area of the reach WB2. (Lower middle) A photo of a bike tire with a tree root growing around it (LW5). (Lower right) Trash inside Beaver Pond.

To many people, a little bit of trash here and there does not seem like an issue. However, as trash moves down the watershed and makes its way to Long Island Sound, the amount accumulates and becomes a concern (see Fig. 1). As construction of highways and residential areas increases in New Haven and many surrounding towns so does the trash and other types of debris and pollutants.

Trash and debris from any source is damaging our watershed. Not only that, it travels down our waterways and empties into Long Island Sound—further harming wildlife. Community awareness is the first step to solving this growing issue. Most people are not aware of their direct impact on the ecosystem. Nature walks along sections of our watershed with the West River Watershed Coalition will allow residents to see that there are streams all around them. The next step is community involvement. Looking at the map we can identified the trash “hot spot” areas. However, there is more trash as we reach the lower areas of the watershed. Perhaps there is a greater issue with trash accumulation in the specific areas reported. In West Haven, there is a car dump as well as a capped landfill that has greatly damaged and polluted the watershed as well as the Sound (see Fig. 1 ALW2). An investigation into the trash accumulation in the unnamed tributaries (ALW 1-3) and a city official led clean-up would help the tributary, but there also need to be laws and regulations set in place to prevent this extent of pollution from trash and debris. Mobilizing residents to report illegal dumping through See-Click-Fix—a community reporting website—could also be a good way to keep track of areas where illegal dumping is happening and may help the city to put some preventative measures in place.
