INTRODUCTION

The purpose of this project was to test the quality of Major Besse Pond to determine if the proximity of the pond to Route 8 and the presence of nesting geese contributed to water contamination. To determine the cause for a visually "unhealthy," appearance and to help indicate contaminants, we sought to measure total dissolved solids, conductivity to determine salinity, nitrogen from geese, and other parameters. Our goal is to establish baseline data so that future students can track this data over time.

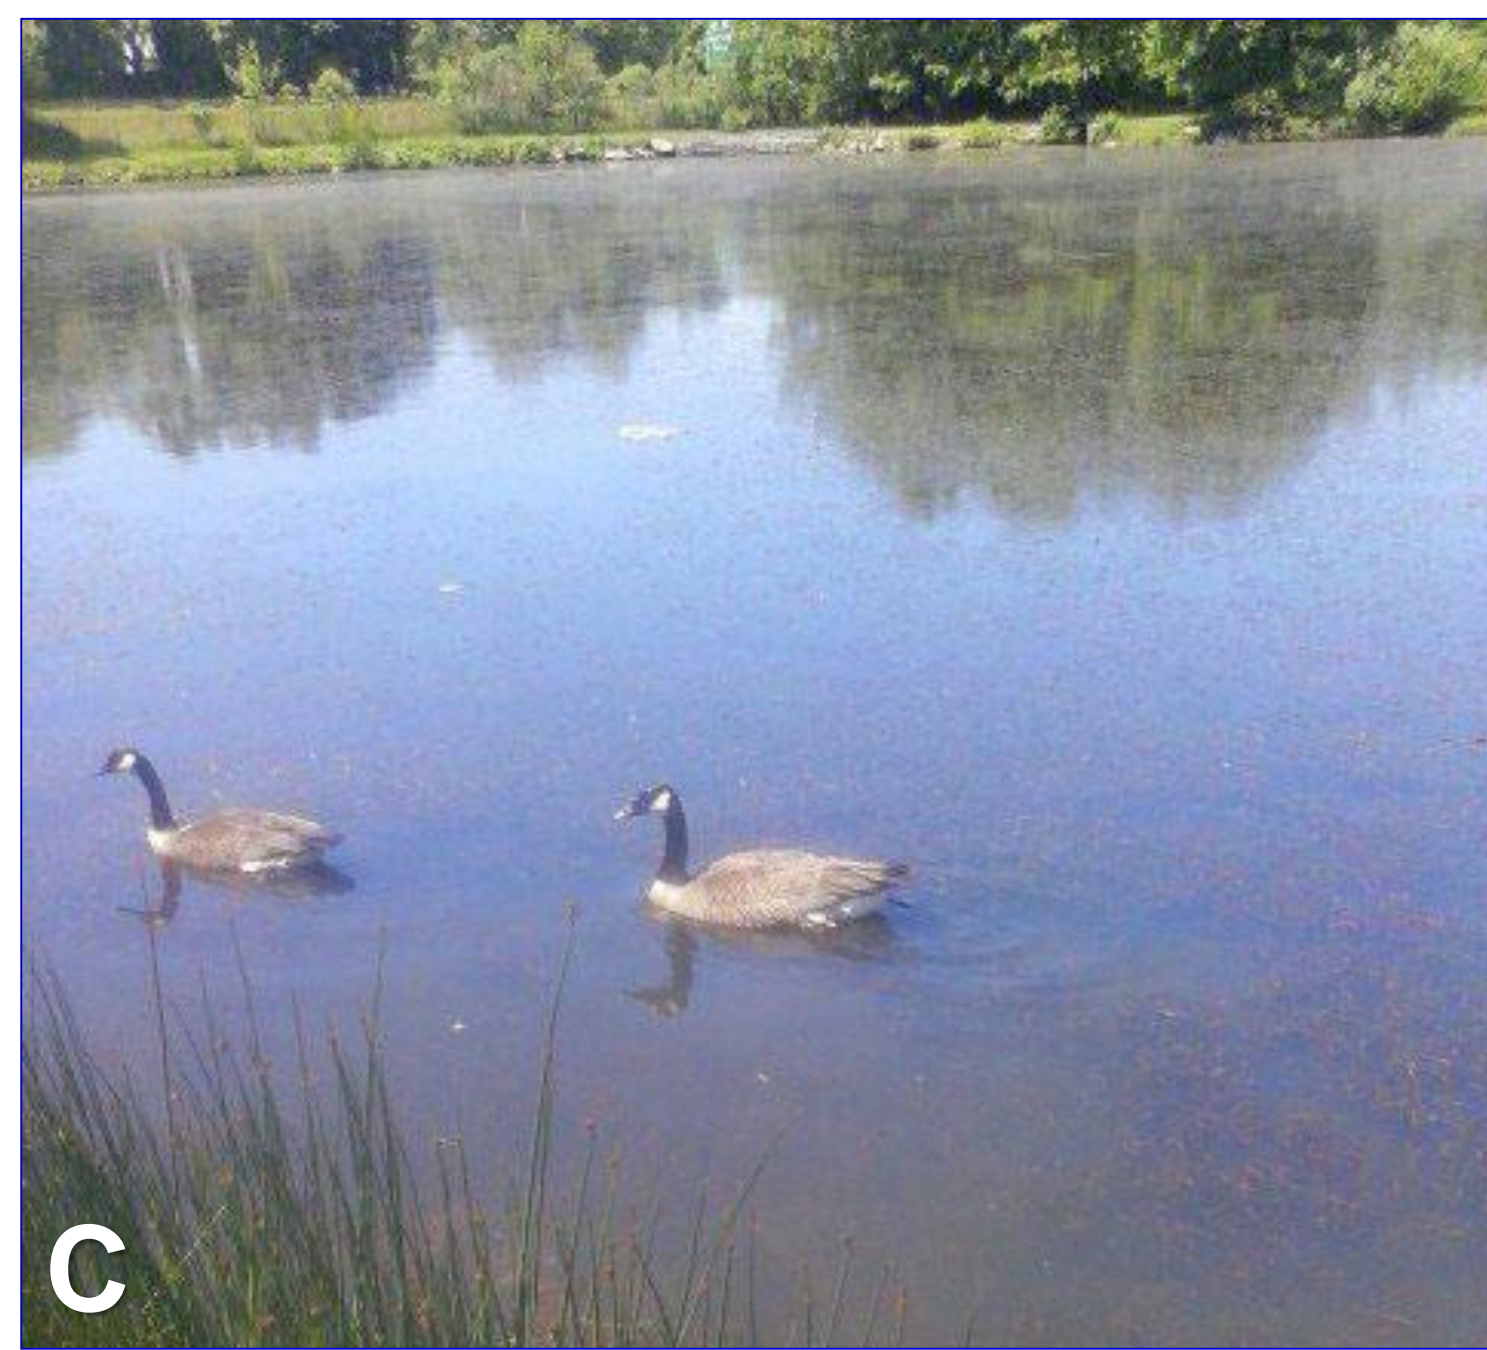
Fig 1. A: Major Besse Pond in 1970; B: Major Besse Pond in 2016. Notice sizable difference in area and shape. A & B photos provided by the City of Torrington. C: Geese and algae blooms in the pond.

Major Besse Pond is located on Torrington High School's grounds, is only a few feet away from Route 8, a well traveled highway (Fig 1), and is very shallow from runoff sediment accumulation. In the warmer months, the pond's water quality appears very unhealthy due to algae blooms, geese and their excrement.
