# Factors Affecting Fishing Quality at the Branford Supply Ponds

NRCA Student: Carter Shannon<sup>1</sup>  
Community Partner: Suzanne Sullivan<sup>2</sup>  
<sup>1</sup> Branford High School; <sup>2</sup> Branford Public Schools

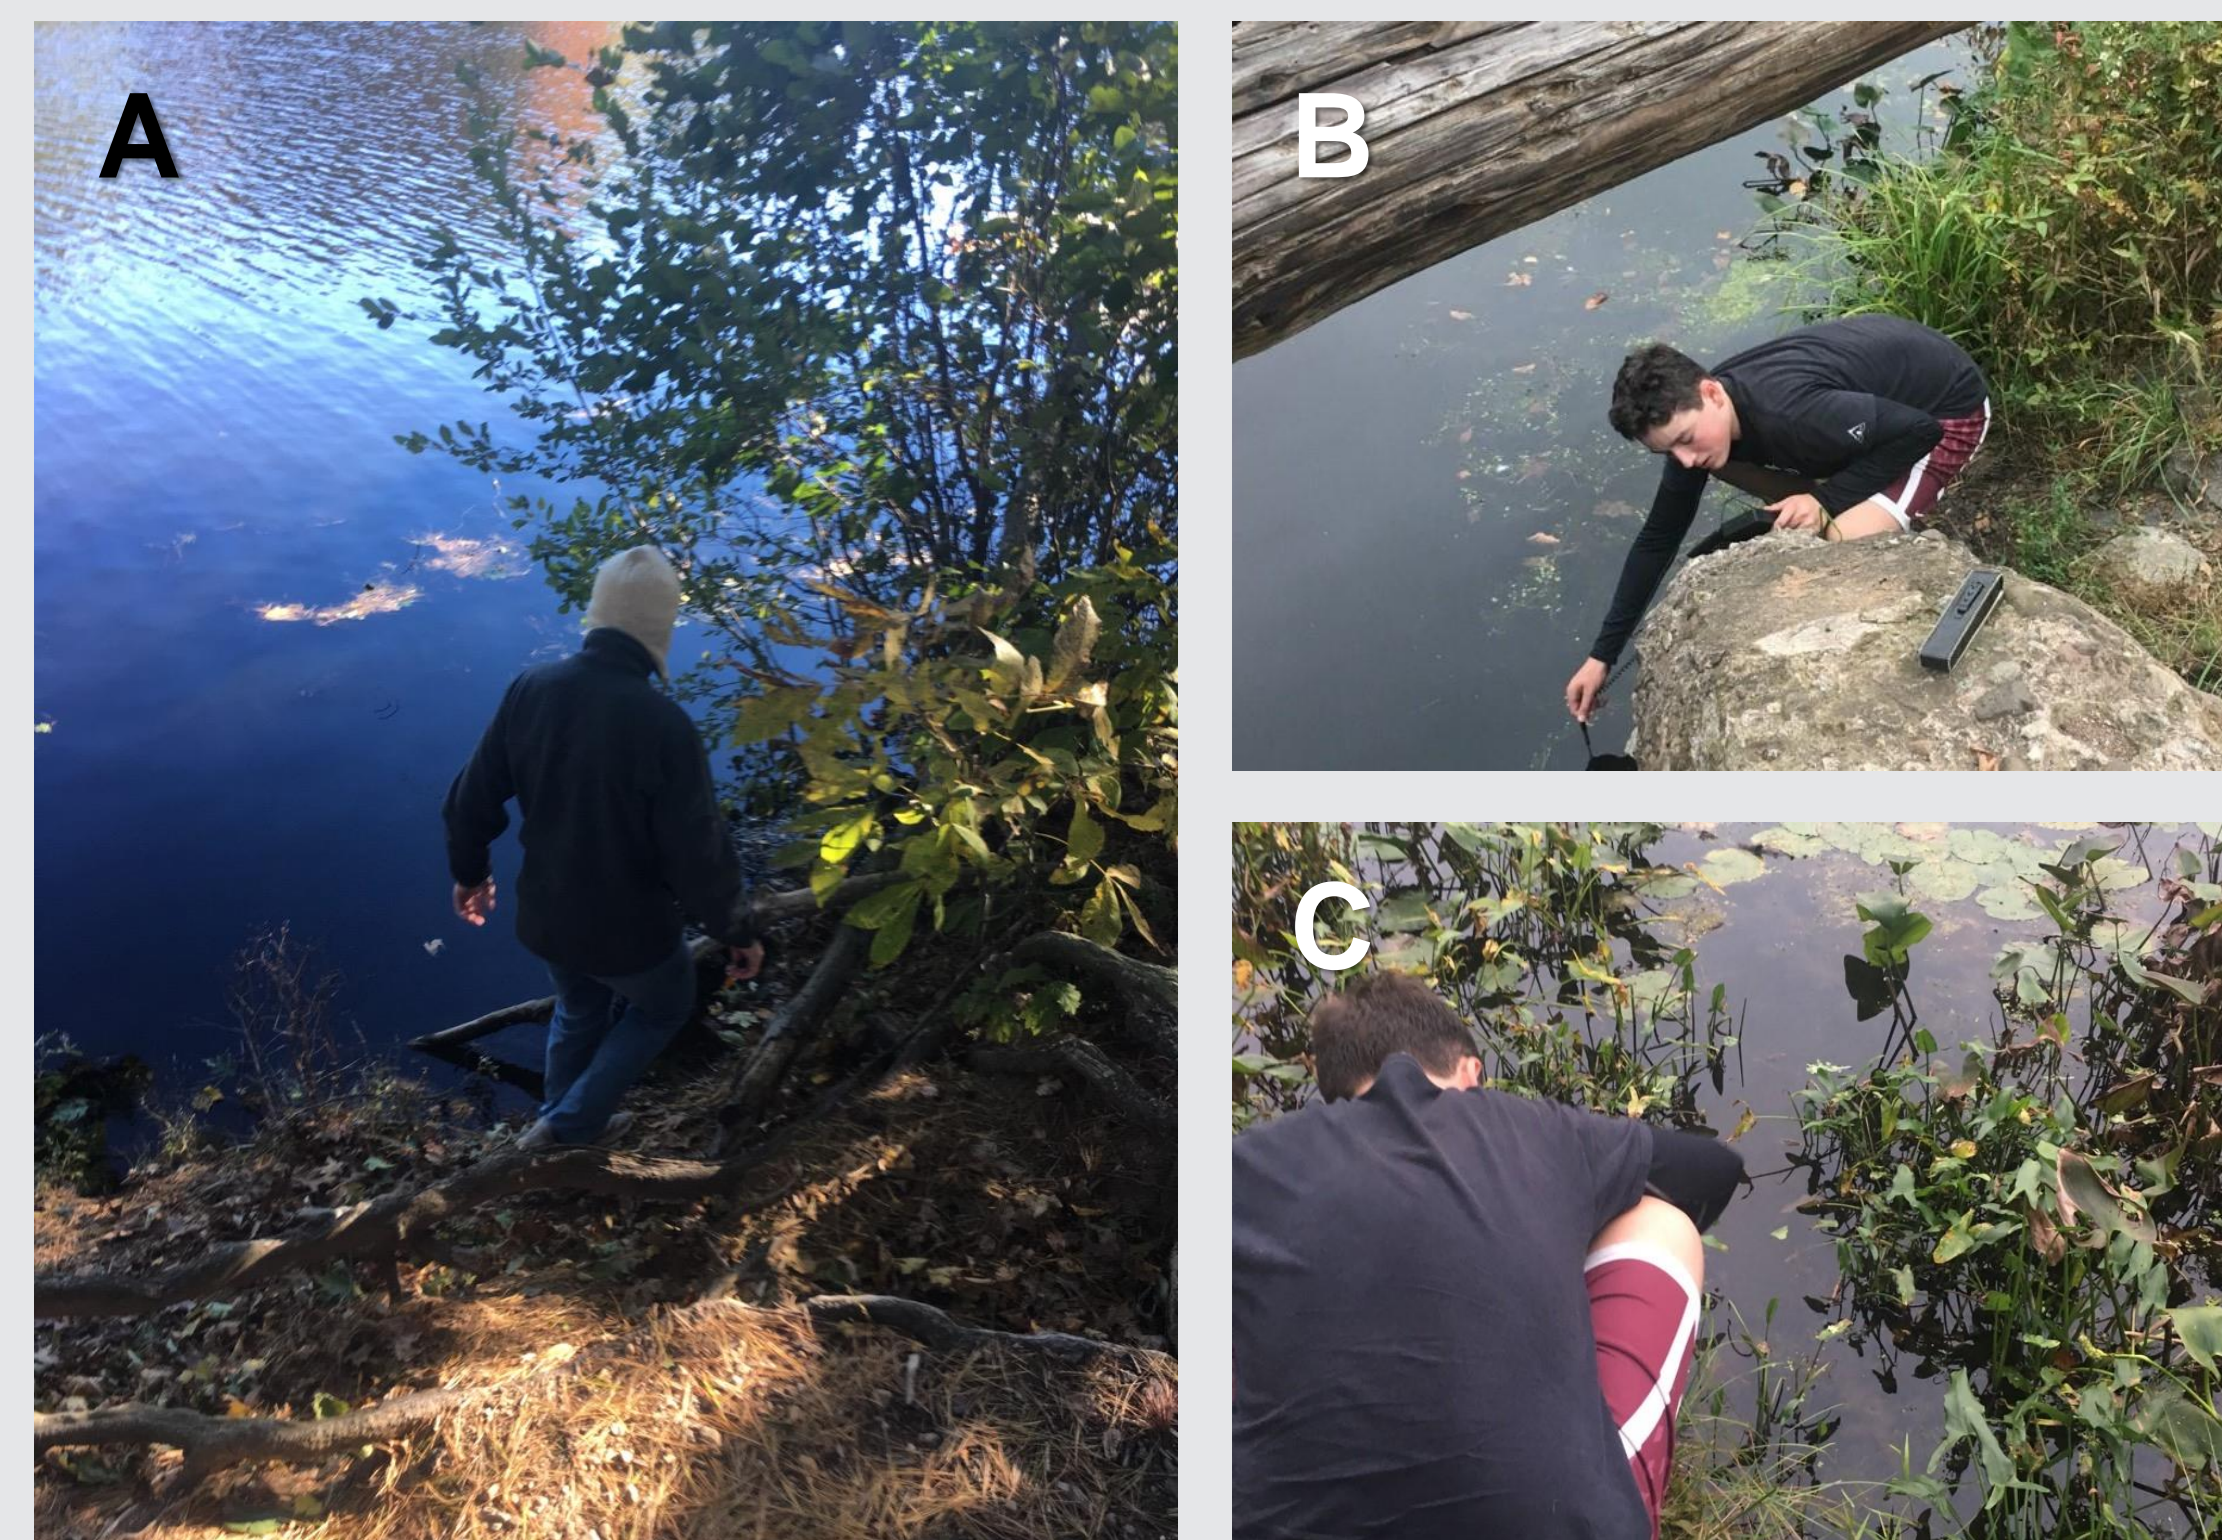
Fig 2. Carter taking water sampling measurements at: A: Site 5; B: Site 1; C: Site 3. See Fig. 3 for site legend.

Using an Ubante TDS meter (model YL-TDS2-A), we sampled water at five sites (Fig. 3) in the Supply Ponds in Branford, CT, three times between October 8th and November 4th, 2018 (Fig. 2).

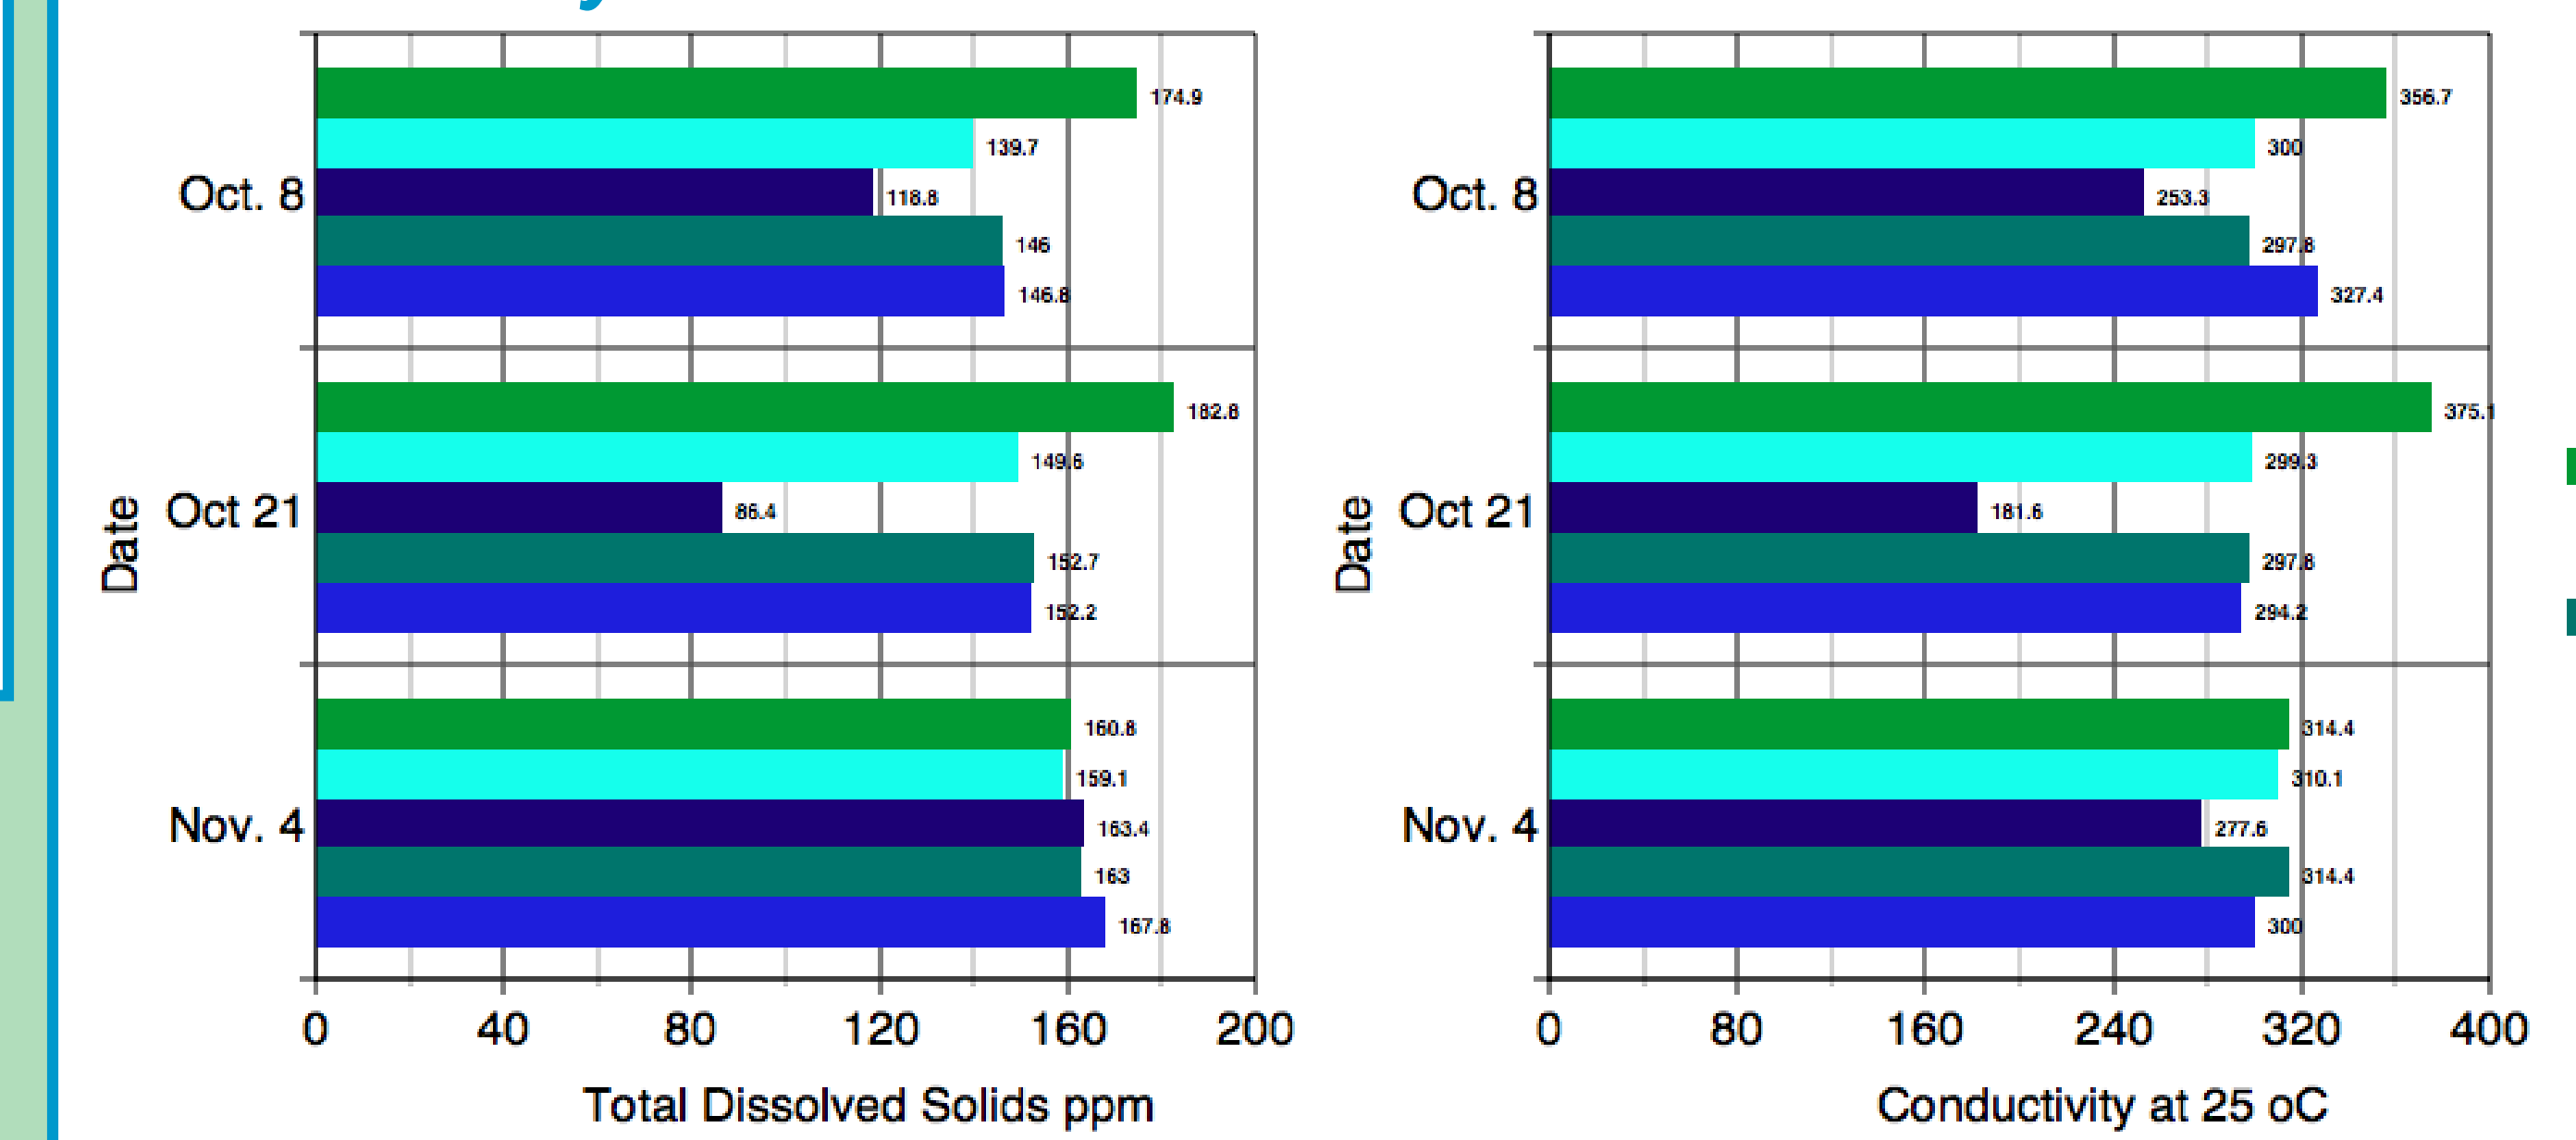
Fig 4. Total dissolved solids and specific conductivity at five sites in the pond during the three survey periods. (Left) Total dissolved solids ranged from 86.4 to 182.8 ppm well within the normal range for healthy fish. (Right) Conductivity ranges from 181.6 to 375.1 µS/cm which is in the range of normal from 150 to 500 µS/cm is normal freshwater range to support diverse species.

- We established baseline values for conductivity and total dissolved solids in different parts of the pond. The samples gathered were all within normal limits (Fig. 4), and since the majority of these samples were obtained before road salts were applied, this finding is not surprising.

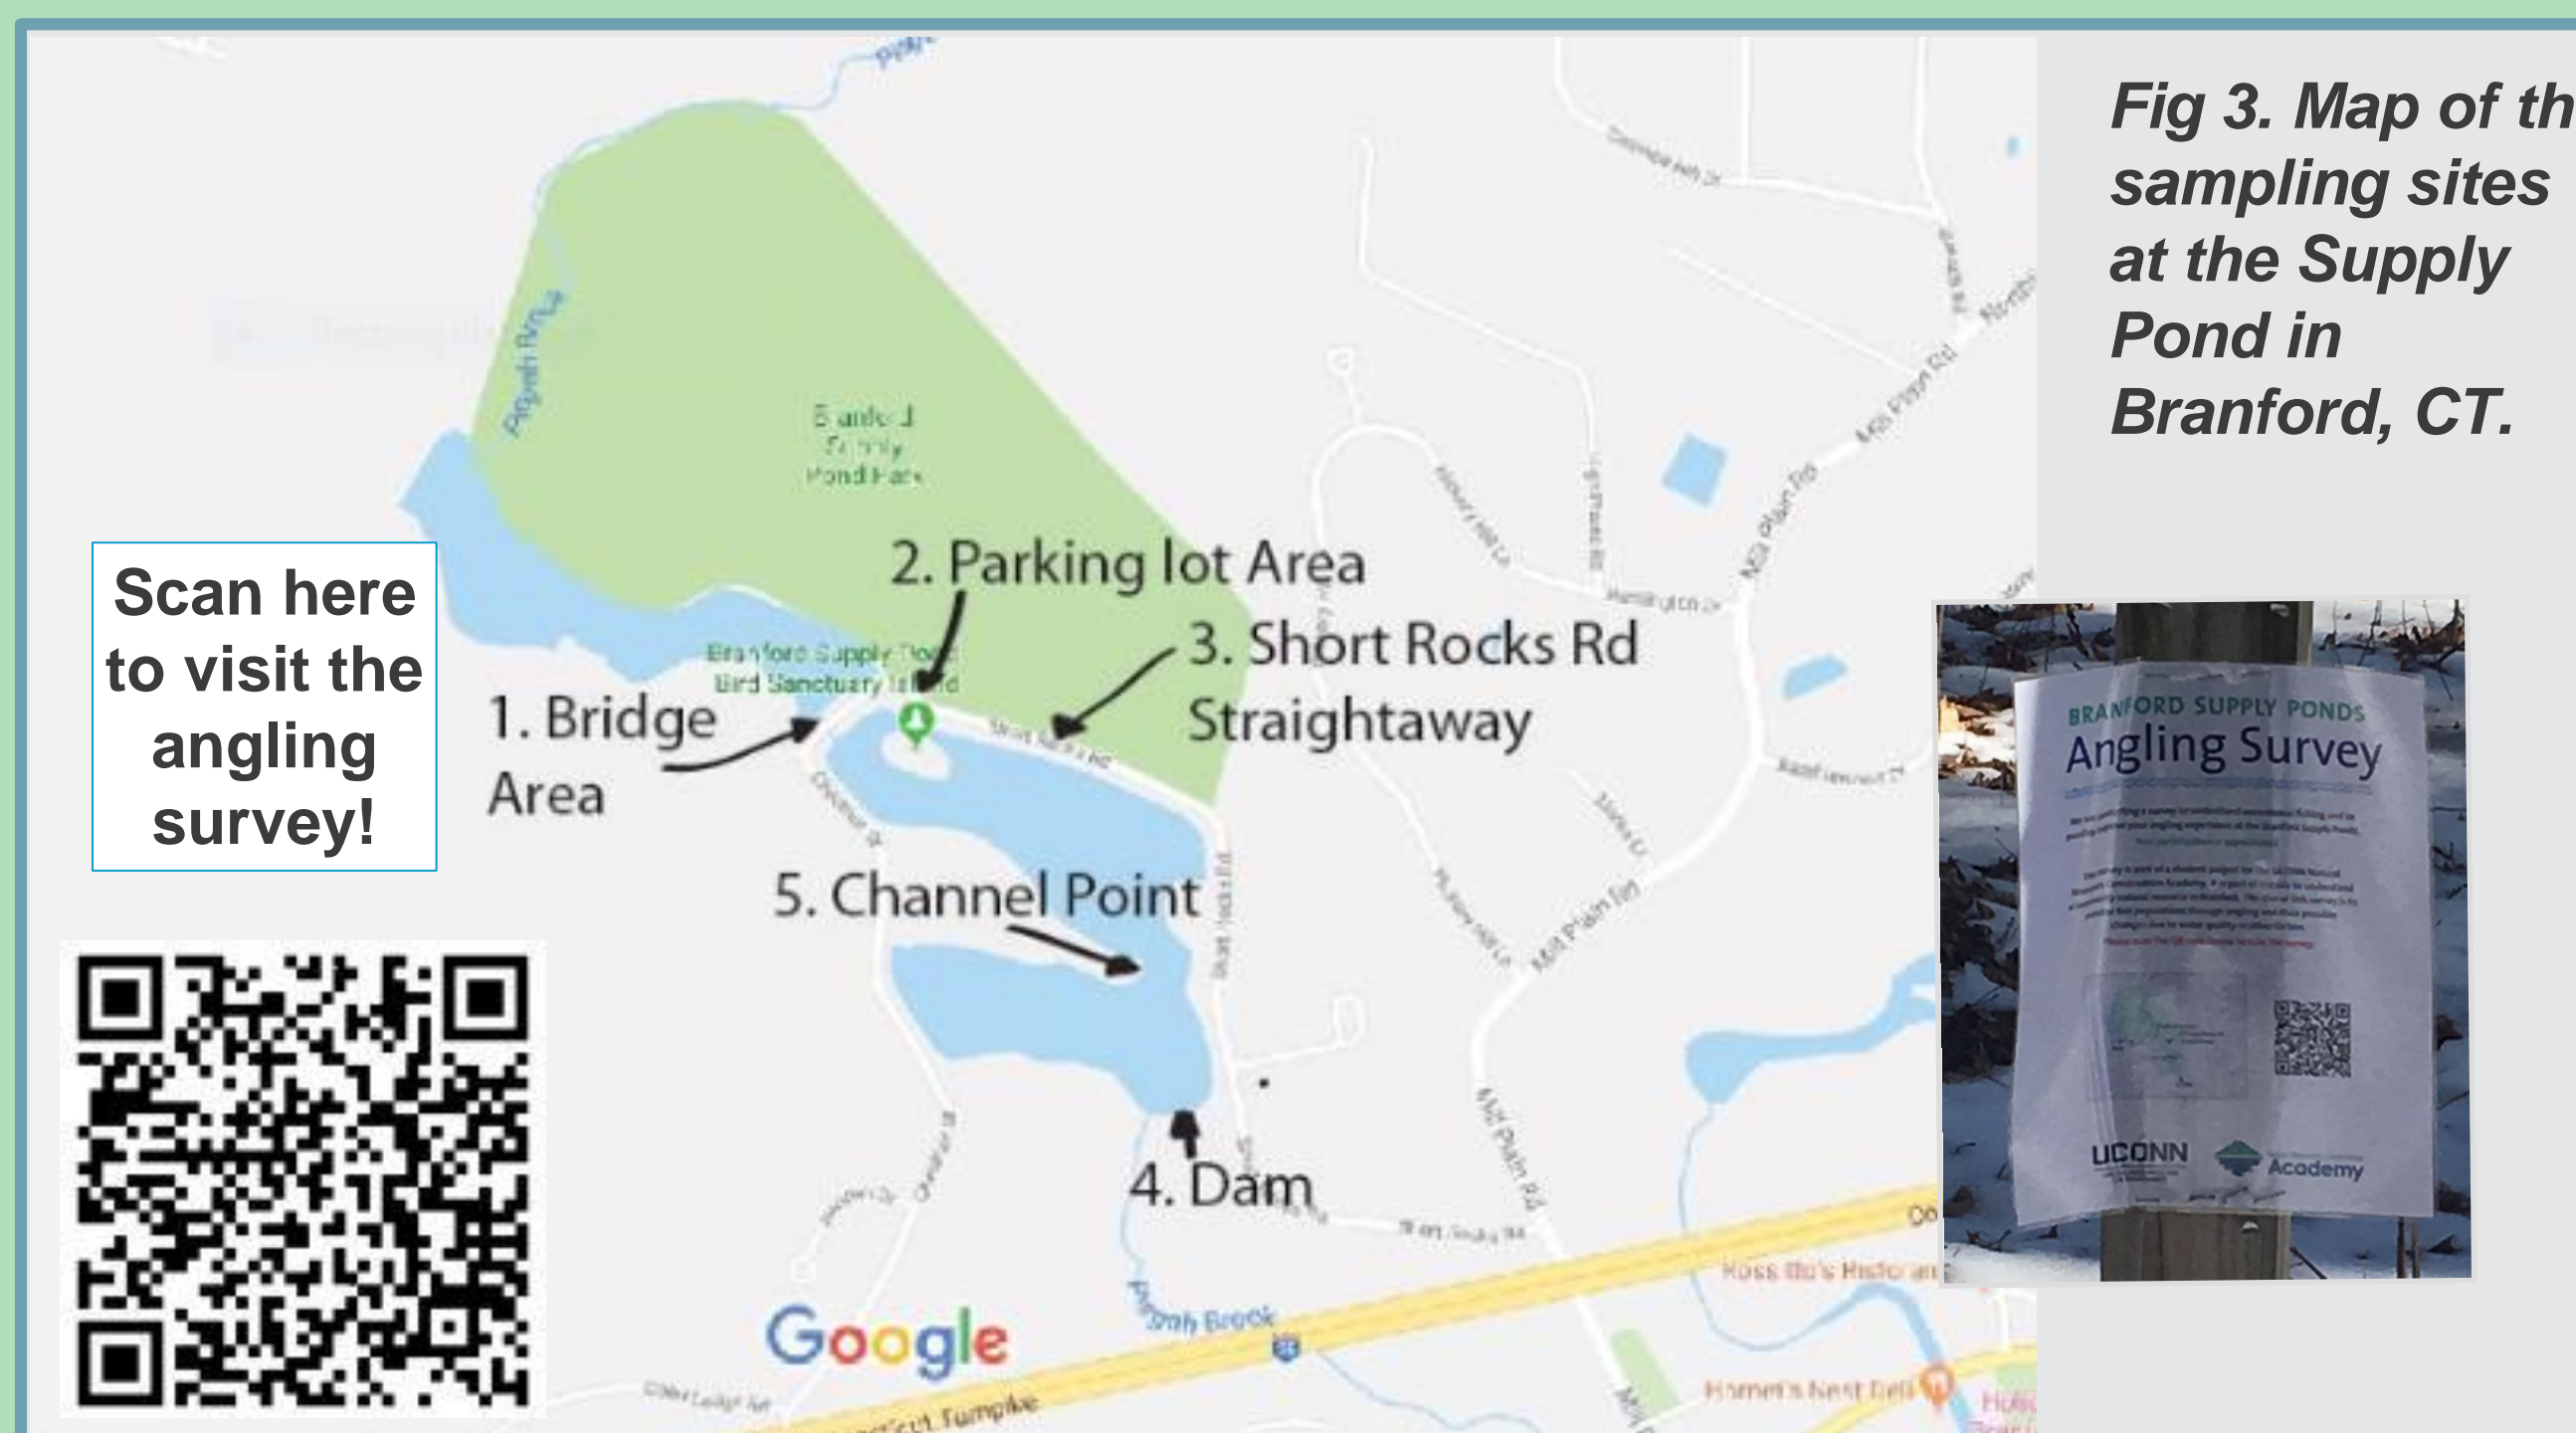
Fig 3. Map of the sampling sites at the Supply Pond in Branford, CT.
