THE IMPACT OF LARGE WOODY DEBRIS ON HABITAT RESTORATION

NRCA Student: Noah Watson¹ Community Partner: Tracy Brown²

¹Housatonic Valley Regional High School ²Trout Unlimited

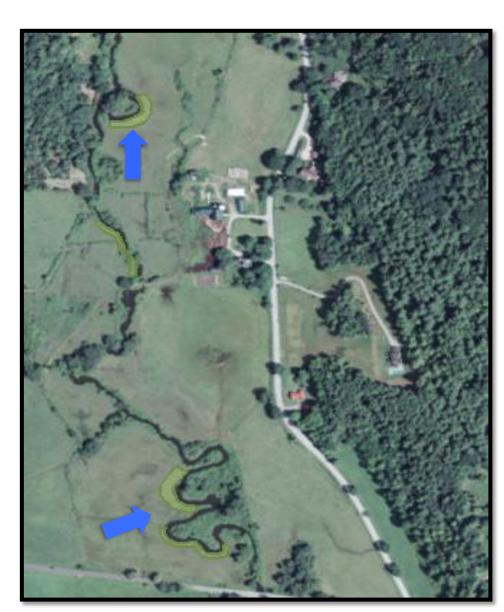
Fig 1. The three restoration sites on the Salmon Kill are highlighted in green. I conducted pre- and postmonitoring of the two sites indicated by and I conducted postmonitoring at one site indicated by T. Trout Unlimited hopes to restore 24 sites along the Salmon Kill.

- Salmon Kill Watershed in northwest Connecticut (Fig.2-A).
- Three unique sites restored-such as Site 2 at Whippoorwill Farm, where restoration was completed (Fig. 1).
- Monitoring of large wood installations occurred at 3 construction sites.

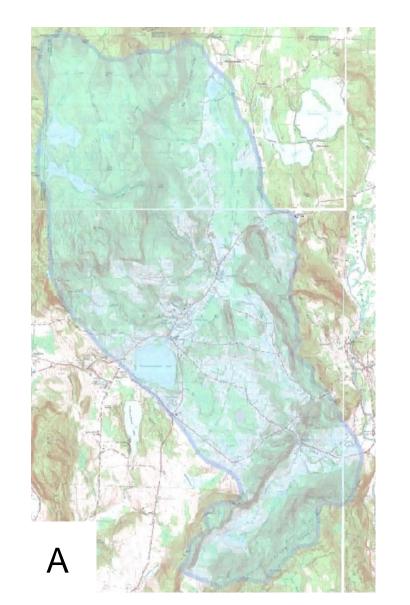
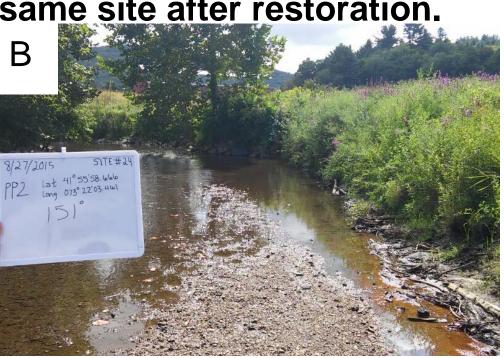
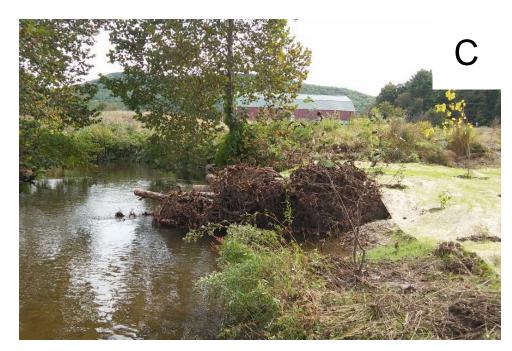
Fig 2. (a) This is a topographic map of the Salmon Kill Watershed. (b) This is a photo of the site before restoration. The whiteboard lists all of the necessary information to identify this site, including coordinates, site number, site name, date, and the photo point. (c) This is a photo of the same site after restoration.

- Step up photo points at two sites prior to implementation of large wood treatments and did follow-up photo monitoring at one site (Fig. 2 B, C).
- At each photo point, I recorded the latitude and longitude using a GPS, and then photos were taken of the site using a whiteboard to report site-specific information.
- I researched the effects of large wood on stream ecology.
- Evaluated the fish data collected before and after restoration at one site.

- The photo points can be used as a standard for which growth of riparian vegetation and structure of the wood restoration can be measured (Fig. 2).
- These points will be used to evaluate the effectiveness of the restoration project.
