Project Squeaky Clean: Mirror Lake Water Quality

Ryan Perusier¹, Chris Bourdan², Tamara Parks³
¹Home School; ²Meriden Parks & Recreation and Ball Headz; ³UConn NRCA

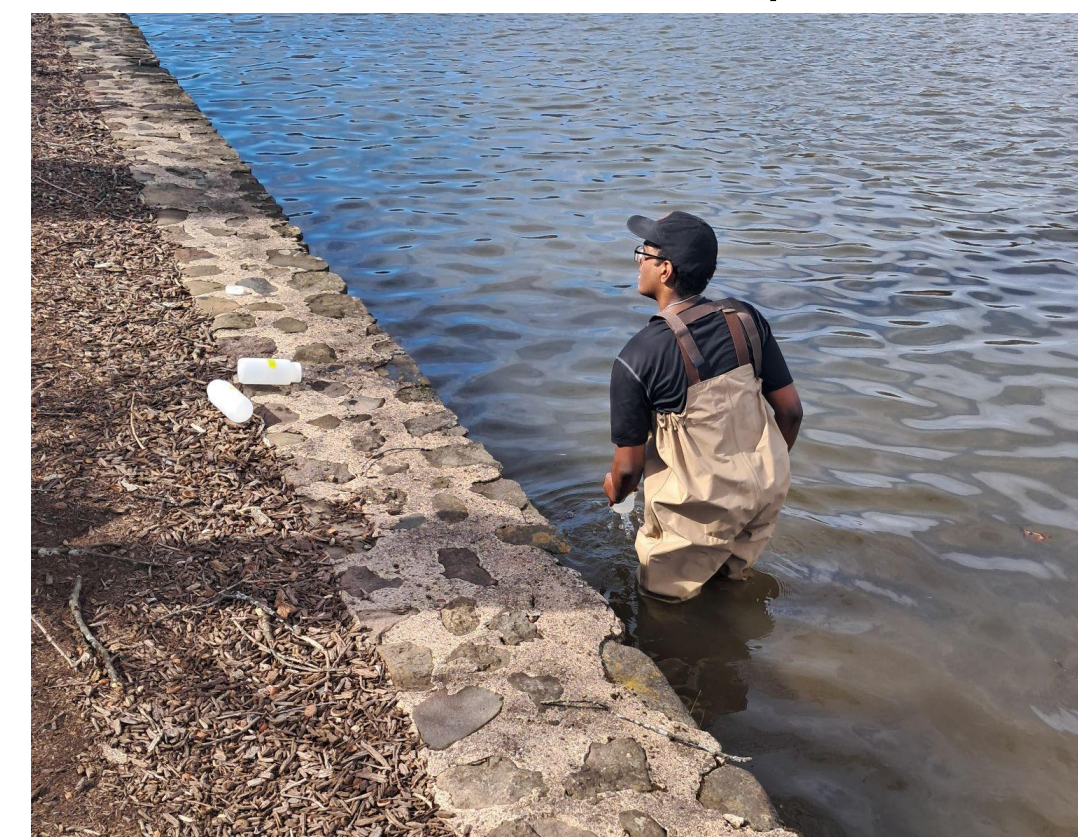
- Preliminary water testing occurred on 10/30/24 (Fig. 7) and water samples were collected 3/10/25 (Fig. 4) at the north (inlet), northeast (shoreline), and south (outlet) areas of the lake.
- Parameters measured in the field: Phosphate, pH, Conductivity, Nitrate, and Total Dissolved Solids (TDS)
- Water samples were also collected on 3/10/25 and submitted to the UConn Center for Environmental Science and Engineering (CESE) for more detailed laboratory analysis.

Figure 4. Testing water in the lake (left); **Figure 5.** Water testing at the CESE laboratory (center and right)

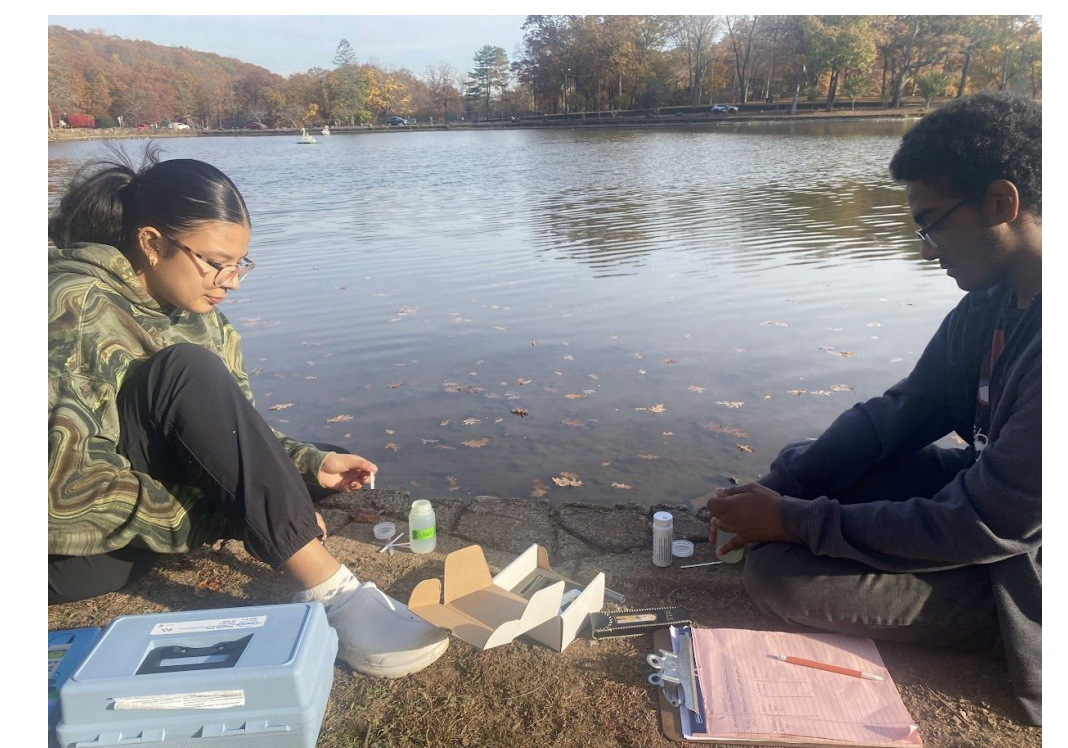
Figure 6. Water sample locations (above); **Figure 7.** Tamara Parks and Ryan Perusier testing water quality (top right); **Figure 8.** Algae bloom at Mirror Lake, taken by Ryan Perusier (bottom right)

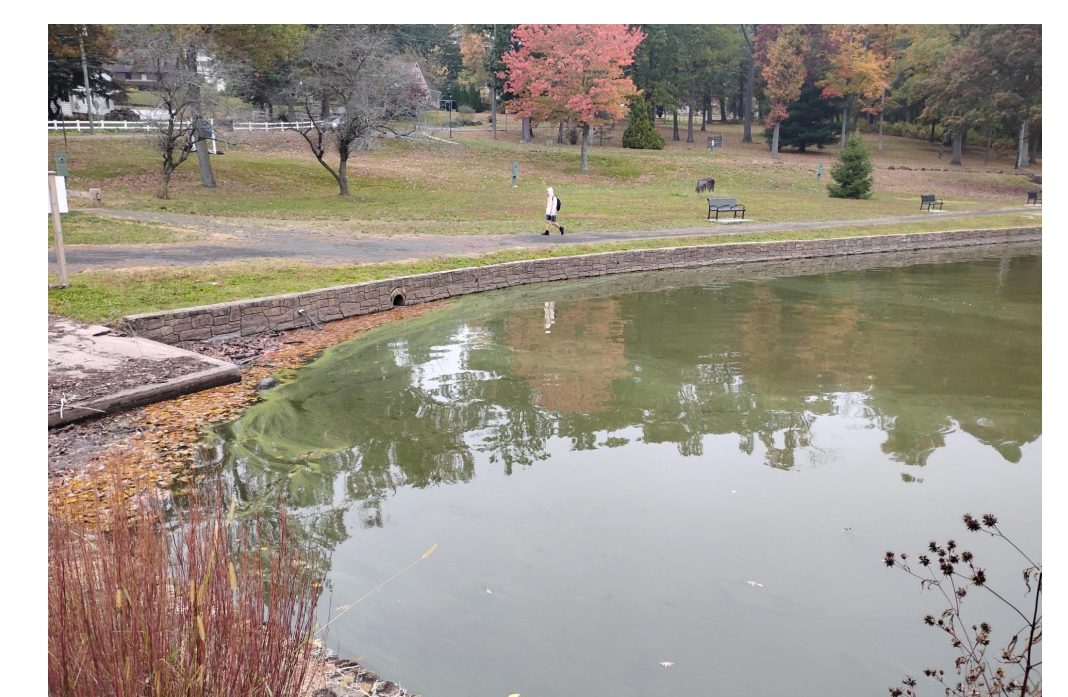
- High levels of Phosphorus at the Outlet (see Table 1)
- Slightly elevated NOx and pH at the Outlet
- The Outlet of Mirror Lake was determined to be eutrophic to hypereutrophic, meaning the water is cloudy with nuisance algal blooms, and likely not able to support healthy aquatic wildlife.

- While the main part of the lake is relatively healthy, it likely experiences **excessive algae growth**, especially near the outlet, which can lead to: low dissolved oxygen levels, potentially harmful algal toxins, blockage of sunlight for plants, and degraded habitat conditions for benthic macroinvertebrates and other aquatic life.
- Pet waste and goose droppings can raise phosphorus levels in the lake, which encourages harmful algal growth. Surprisingly, four adult geese can contribute as much phosphorus as a single septic system.
- Next steps include providing solutions to safely lowering the phosphorus levels through substances such as aluminum salts, lanthanum-modified bentonite clay, and algaecides.
